**DEPARTMENT OF TRANSPORTATION****DIVISION OF ENGINEERING SERVICES**

Contract #: 04-0120F4Cty: SF/ALA Rte: 80 PM: 13.2/13.9File #: 69.28**WELDING INSPECTION REPORT****Resident Engineer:**Siegenthaler, Peter**Address:** 333 Burma Road**City:** Oakland, CA 94607**Report No:** WIR-019263**Date Inspected:** 19-Dec-2010**Project Name:** SAS Superstructure**OSM Arrival Time:** 700**Prime Contractor:** American Bridge/Fluor Enterprises, a JV**OSM Departure Time:** 1900**Contractor:** Zhenhua Port Machinery Company, Ltd (ZPMC), Changxing Island **Location:** Shanghai, China**CWI Name:** Qiu Wen.**CWI Present:** Yes No**Inspected CWI report:** Yes No N/A**Rod Oven in Use:** Yes No N/A**Electrode to specification:** Yes No N/A**Weld Procedures Followed:** Yes No N/A**Qualified Welders:** Yes No N/A**Verified Joint Fit-up:** Yes No N/A**Approved Drawings:** Yes No N/A**Approved WPS:** Yes No N/A**Delayed / Cancelled:** Yes No N/A**Bridge No:** 34-0006**Component:** OBG components.**Summary of Items Observed:**

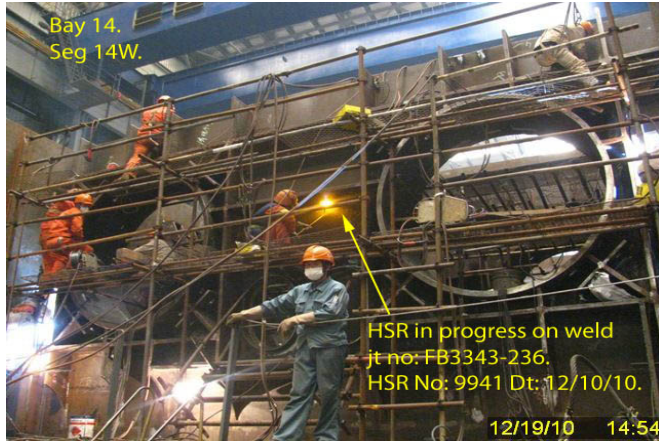
ZPMC personnel performing heat straightening on weld jt no: FB3343-236. Heat straightening was done as per Heat Straightening Report (HSR) no: 9941 Dt: 12/10/10. ZPMC QC was identified as Zhu Lin. See attached photo for details.
